# Field Study News

## WaterResistant solutions

Phonak M H2O and Naída S CRT

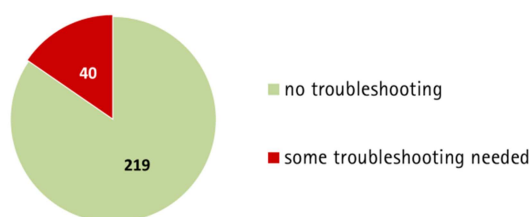
Figure 1: Activities overall with and without troubleshooting (n=259)

Since the mechanical housing design for the Phonak M H2O and Naída S CRT is the same, the results for both groups can be considered together. Statistical results for both groups show that in 219 of 259 documented activities, no troubleshooting of the devices was required. In the remaining 40 activities minor troubleshooting was necessary to restore devices to functioning condition (see Figure 1). In 39 of these 40 cases, after ventilating the battery or cleaning the sound exit, the devices were functional.

Activities overall without and with troubleshooting (n = 259)

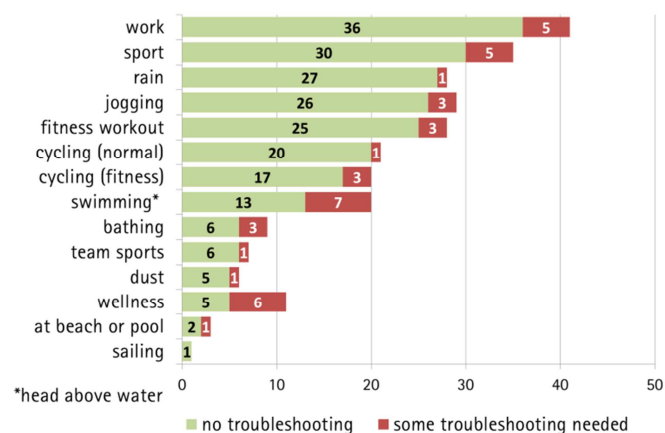
Figure 2: Activities without and with troubleshooting (n=259)

Analysis of the documented activities shows that the activities "swimming with head above water" and "wellness (spa)" required the most troubleshooting (see Figure 2).

Activities without and with troubleshooting (n = 259)

The activity "wellness" included visits to a sauna or steam bath, which are highly negative conditions for zinc-air batteries due to high temperatures or humidity. This leads to insufficient battery voltage and therefore minor troubleshooting was required. After ventilating or changing the battery, all devices functioned again. As stated in the introduction, this battery issue is not related to the housing design, but is an inherent weakness of zinc air batteries.

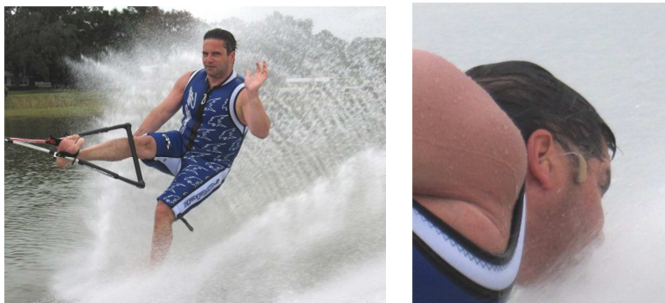
This subject tested a pair of Naída S CRT in an exceptional use case situation, which is clearly not recommended. Fitted with cShells and a helix lock, he wore the devices while barefoot water skiing in Florida (see following pictures).

Despite the devices being subjected to high water pressure during four runs of 1 min each, they continued to function. On the fifth run, water entered the battery doors and the devices stopped working. After drying the devices, full functionality was restored.
